ROCK FALL CASE STUDY: HAWKESBURY SANDSTONE

Daniel Bishop¹, Stephen Fityus², David Piccolo³ and Garry Mostyn³

¹Research Associate, University of Newcastle, ²University of Newcastle, ³Pells Sullivan Meynink.

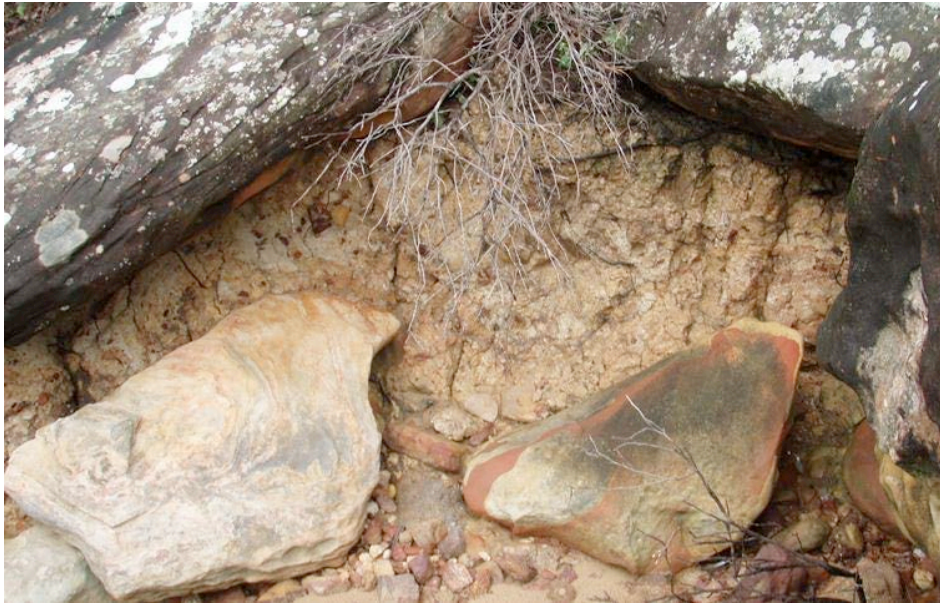
Figure 3: Colluvium on lower slopes of valley at sea level. Site is being eroded by marine activity.

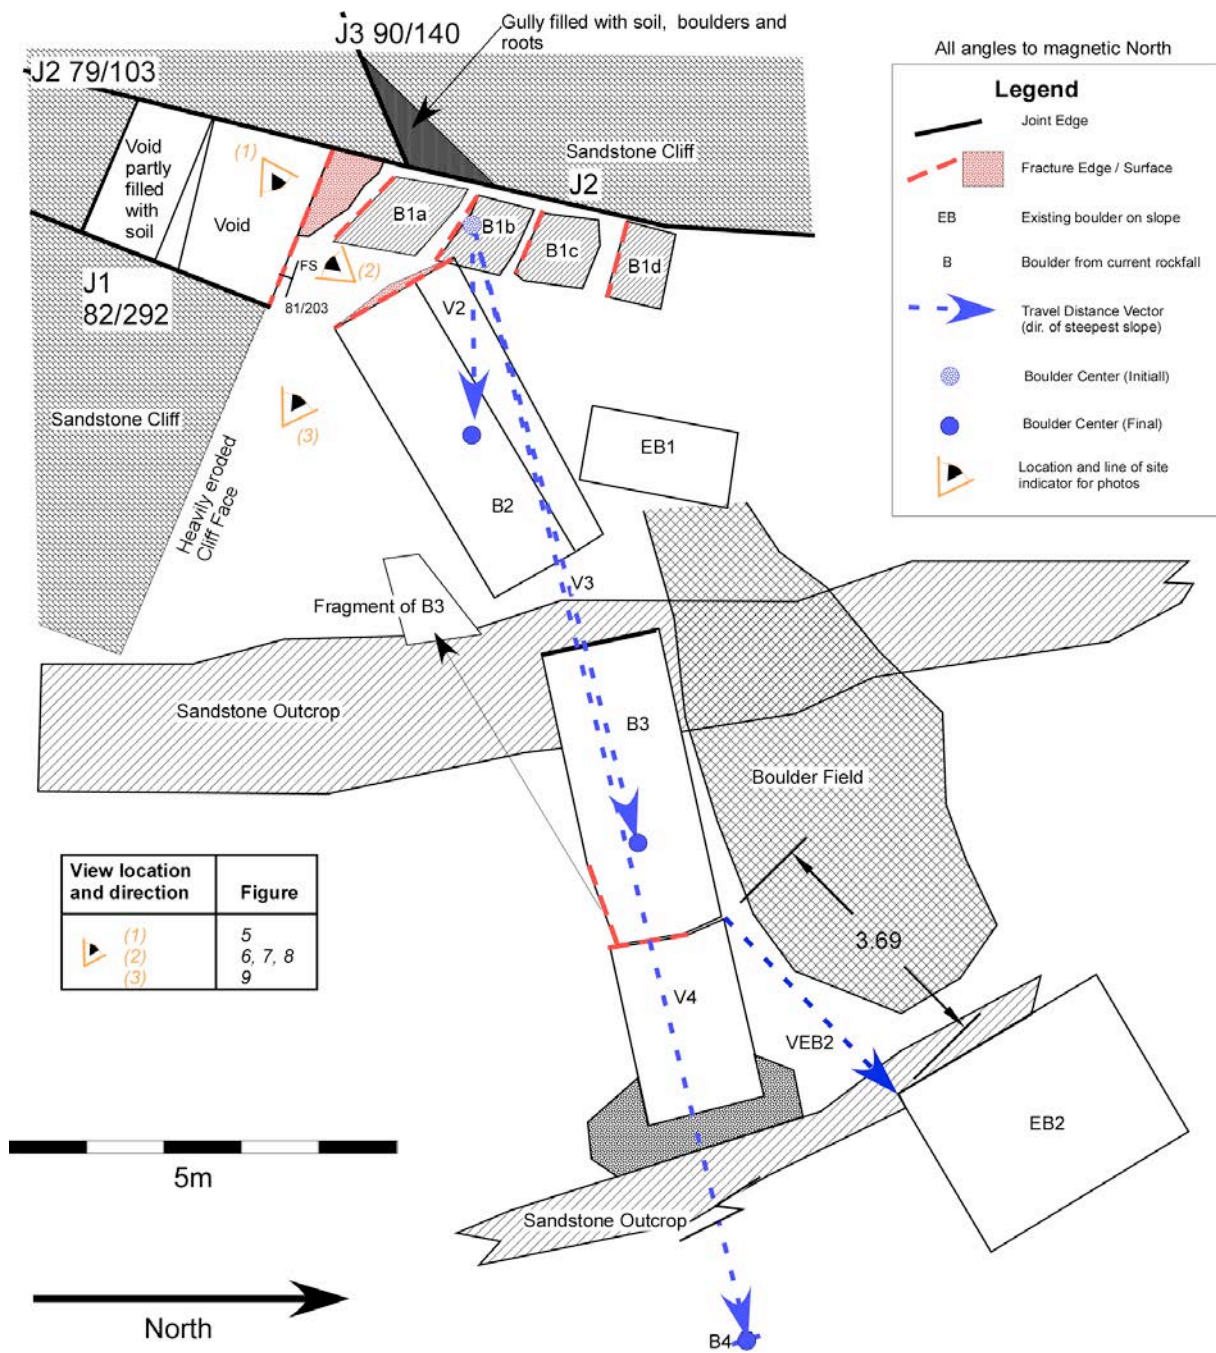
The boulder field, the outline of which is shown in Figure 4, comprises rock fragments, (pebbles to boulders), soil and leaf matter dislodged during the rock fall event. The size of the largest boulder in the boulder field is around 0.1 m (0.001 m³)² to 3 orders of magnitude smaller than the system of larger boulders that form the main volume of this rock fall. The boulder EB2 (Figure 4) was already present on the slope at the time of the failure and was impacted by boulder B3 and shunted approximately 5 m further down the slope. The furthest distance a boulder travelled from within the rock mass that failed was boulder B4, which came to rest against a tree approximately 30 m downslope from the rock fall source.

Figure 4: Plan view of rock fall, showing final position of the blocks and the interpreted original location of the block centres. Also shown are the photo locations and sandstone outcrops associated with the underlying Narrabeen Group rocks.

- B3 impacted EB2, and landed on slope, resulting in the fragmentation of B3 (Figure 4). Associated debris either cascaded from the blocks as they moved (i.e. rocks within the debris field, Figure 4) or was ploughed forward by the falling blocks.

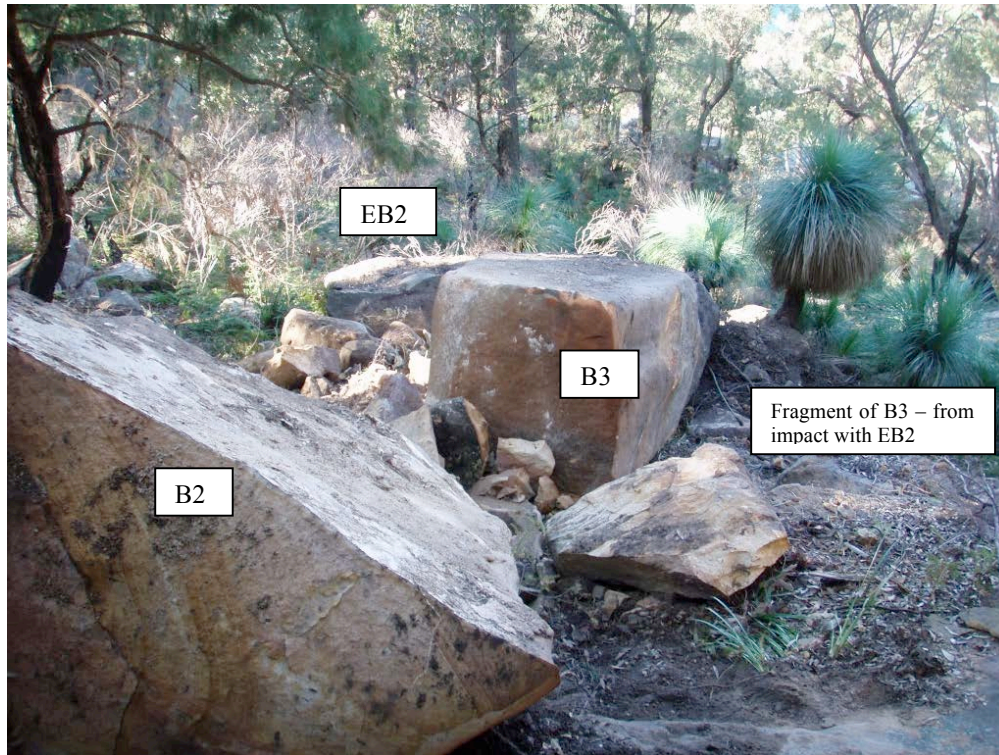
Figure 5: Extent of debris slide viewed downslope from the base of the cliff – Refer to Figure 4

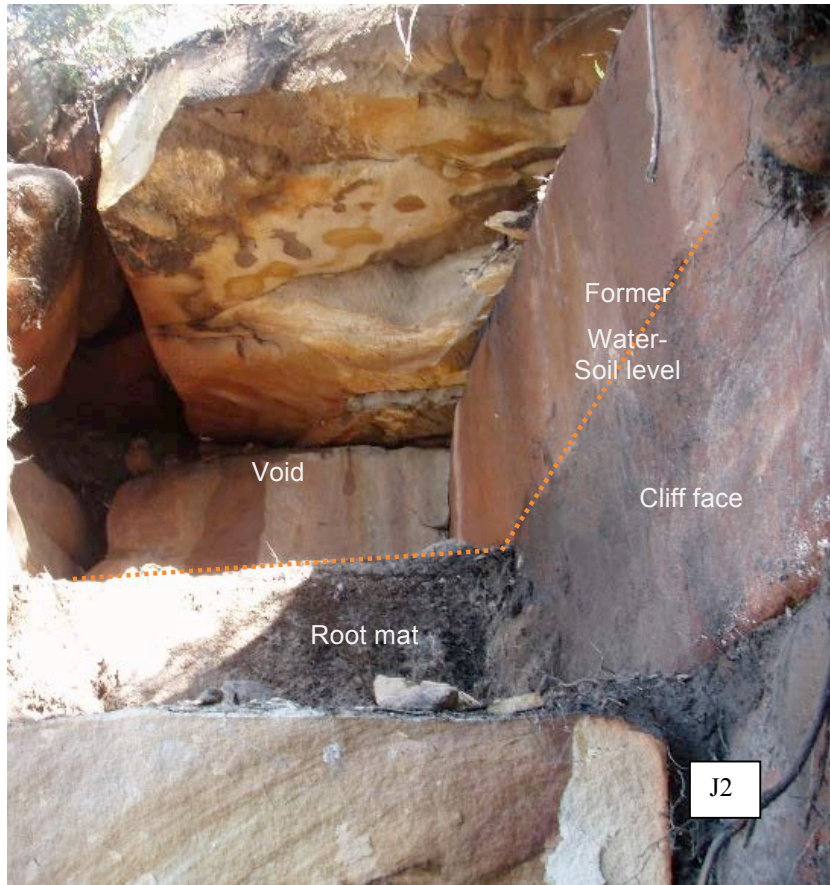
In Figure 6, the organic root mass that filled the base of the void at the rear of the pre-rock fall position of boulder B3, is clearly visible. Also shown is a dashed orange line which marks the water/soil level prior to failure. Water seepage clearly visible on rear wall suggests water levels would have been higher during peak flow. In Figure 7, the fresh fracture surface, on the *in situ* portion of B2, indicates that the rock fall was a very recent event. The gouge mark (orange circle) on lower right of picture indicates the rear corner of failed portion of B2 rotated upwards and away from cliff face during the rock fall.

Figure 6: Photo showing open void that existed at the rear of B3 when it was *in situ*.

- the presence of a well consolidated soil mass with tree roots (Figure 6) indicated that the void has opened gradually by a creeping movement of B3, well before the rock fall occurred,

- water marks on the wall in which the gully is located indicated that water levels could have been maintained 0.5m above the floor of the void (Figure 6), at least during heavy rainfall,

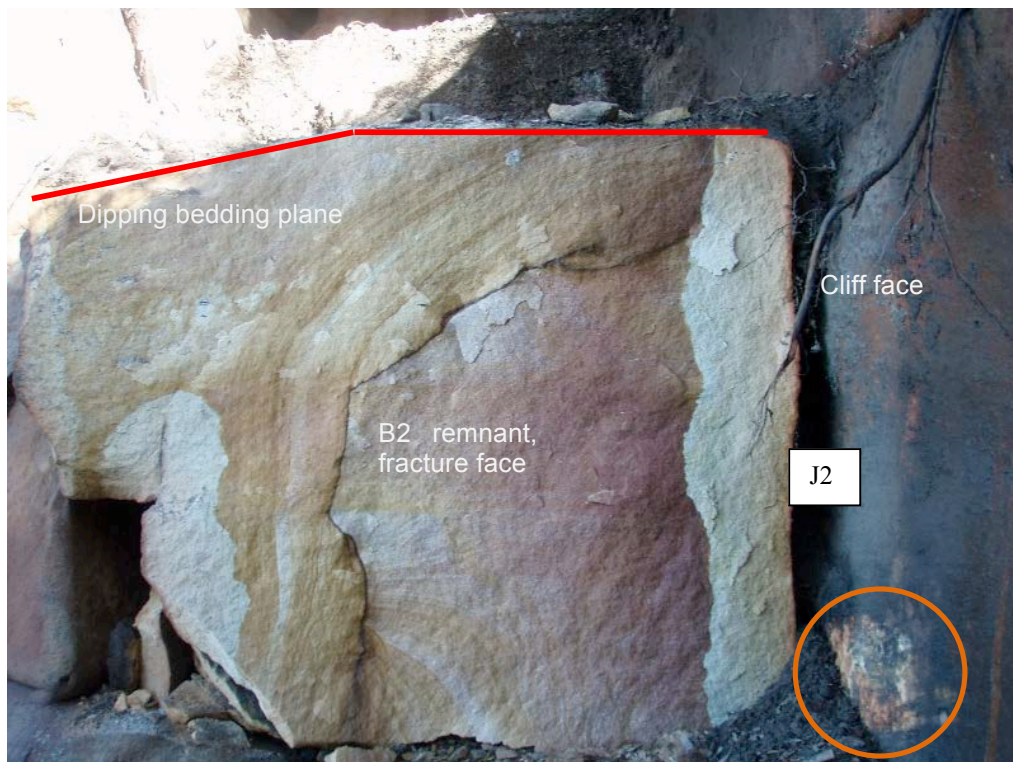
Figure 7: Fresh fracture surface on the *in situ* portion of B2.

The incremental movement direction of Block B3 prior to the rock fall was predominantly parallel to the cliff face (i.e. to open the void). This is interpreted from the fact that the root mat filling the void behind B3 has a vertical margin that is perpendicular to the cliff face (Figure 6 and Figure 11). The texture of the root mat indicates that it would have been in full contact with B3 prior to the failure, meaning that J2 (Figure 6) would have been essentially closed. The upper surface of block B2, which B3 was initially resting on, is partly dipping outwards from the cliff face (Figure 7), encouraging sliding and lowering the available frictional resistance.

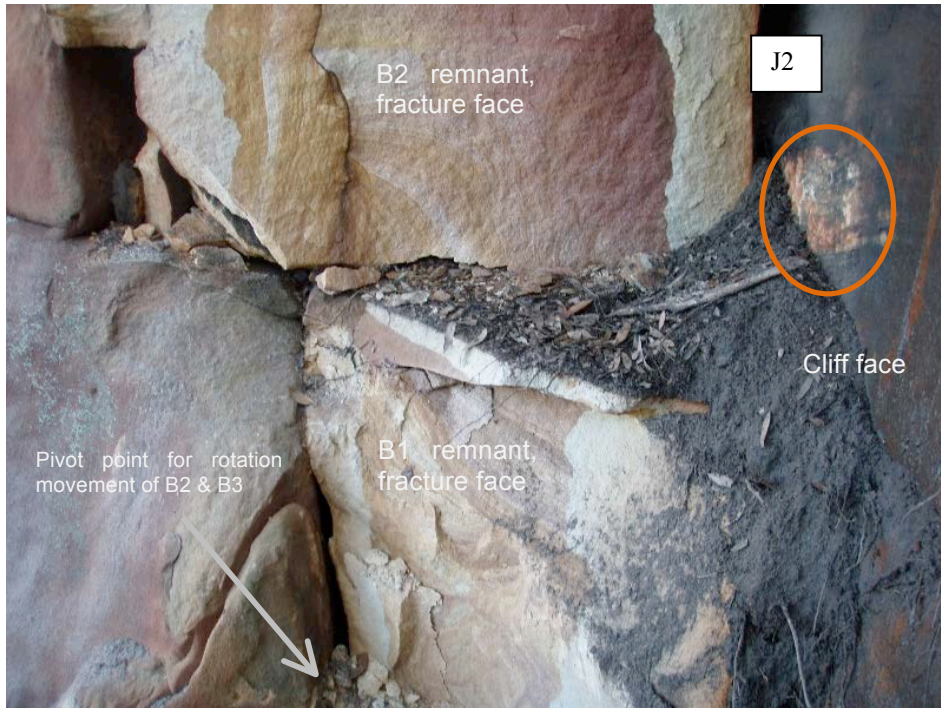
The fracture surface on *in situ* portion of B1, Figure 8, has an identical character to that of the *in situ* portion of B2. The surface defines an acute angle relative to the fracture in the block above (B2). This fracture orientation shows how the rotational movement of the rock mass away from the cliff, indicated by the gouge mark (orange circle) would have occurred. A significant gully, within the rear wall exposed by the rock fall (Figure 9), is clearly visible. Water seepage could be seen within this gully three days after the last (minor) rainfall event, suggesting that during major rainfall events, large volumes of water would have flowed through this location. The large volume of water is also indicated by the fact that the gully is filled with a substantial quantity of coarse debris. The wall is the remnant surface of the joint, J2 (Figure 4) that would have separated Blocks B1, B2 and B3 from the wall prior to the rock fall.

Figure 8: Fracture surface on in situ portion of B1; note acute angle relative to fracture on block (B2) above and the gouge mark (orange circle); see text for description.

The mode of failure of B1 and B2 is interpreted as being a “cantilever failure” (Selby 1993). In this type of failure, locally varying support of overhanging blocks produces tensile stresses that are concentrated in the upper portion of the block, while below a neutral axis through the central portion of the block compressive stresses occur. The rock is most likely to fail in tension as the tensile strength is typically much lower than the compressive strength (Brady and Brown 2005). Tensile strength is, however, extremely sensitive to pre-existing defects within the intact rock mass. There is clear evidence in this study that the rock in each fracture surface is not completely uniform, with evidence of some pre-existing fractures, and the strength is therefore likely to have been lower than any intact strength (Figure 7 and Figure 8).

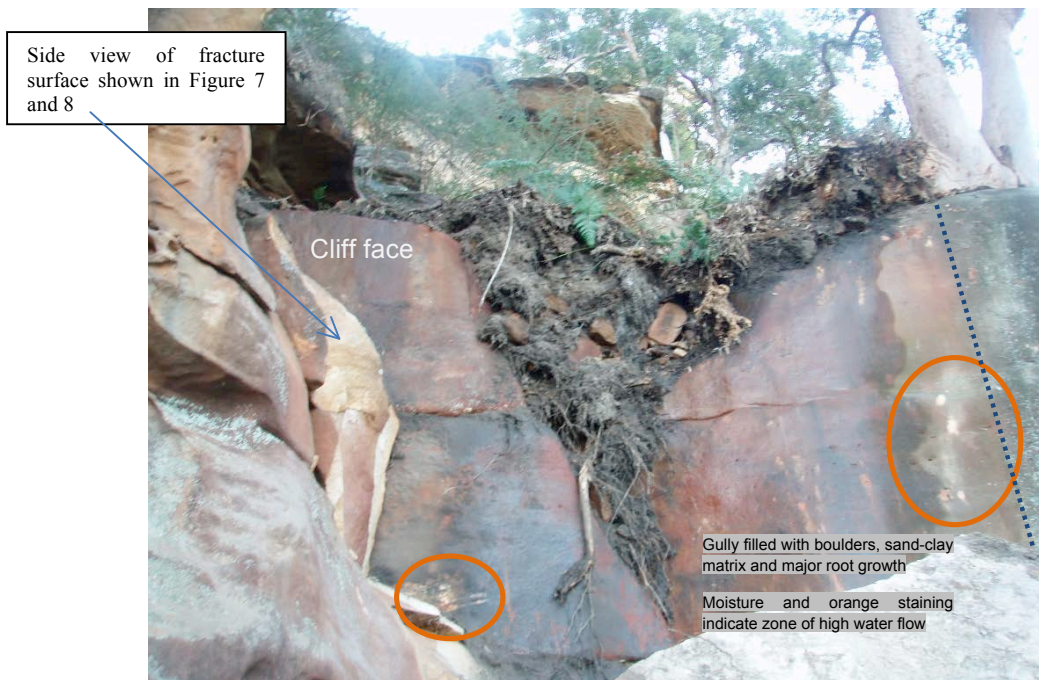
Figure 9: Large gully within rear wall of cliff, exposing one surface of the Joint, J2 (Figure 4).

- the soil and boulder filled gully in the face behind B3 provided an opportunity for porous material with delayed drainage to hold water for brief periods during heavy rainfall, and also an access point for tree roots to intrude between B3 and the face (Figure 9),

- large tree roots were exposed on the wall which would have been the joint (J1-J2, Figure 4) between blocks B1,B2,B3 prior to the failure (Figure 9),
- B3 had been stable through the preceding 4 significant rain events since the 9th January rain event.

- Dripping water along J2 (Figure 9) from bedding planes and base of gully (Figure 8),
- Residual dampness over cliff face (Figure 9) and around the gully,
- Intensive orange staining and flow weathering over cliff face around gully with sharp boundary to lichen covered grey sandstone away from gully (Figure 9),
- Large boulders in sand-clay matrix and concentrated root growth filling a gully, with thick colluvium and a ground surface higher than the upper surface of B3, prior to failure (Figure 11),
- Fresh rock exposed in *in situ* fractured boulders.

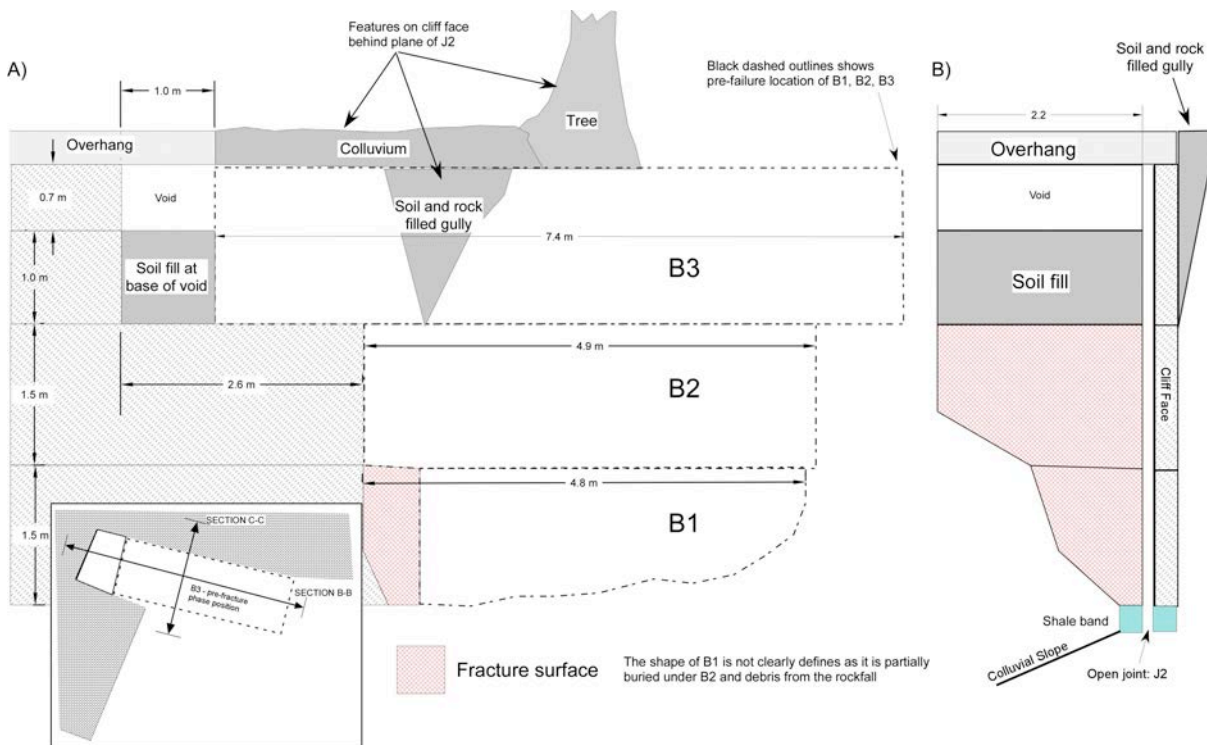
A cross section along the centre line of the remnant failed cliff is shown Figure 11A and a section across the failed surfaces is shown in Figure 11B. The locations of these sections within the rock fall site are shown in the insert in the figure. The original and pre-rock fall positions of B3, shown by the grey and black dashed lines in Figure 11A respectively, have been interpreted from the fact that the void, which has become partially filled with soil and roots, is not a feature of the rock forming process. The pre-failure location of blocks B1, B2 and B3 is reconstructed from measured dimensions of the blocks and a visual correlation between the new and old fracture surfaces. The soil- and

Figure 11: Sections through remnant failed rock mass A) Section B-B, parallel to cliff face and B) Section C-C, perpendicular to cliff face.

The incremental movement of B3 is most likely to have been initially driven by intermittent water pressure build up in the debris-filled gully and in the vertical open joint (J2, Figure 6, Figure 11) between B1, B2 and B3 and the sandstone cliff. The role of water in driving creep processes in rock masses is not straightforward. It is postulated that the build-up

- The incremental movement of B3 would have been progressively modifying loading conditions of the underlying blocks, B2 and B1 (Figure 11).
- B1 is likely to have yielded first, probably by splitting due to the load from B2 producing direct and/or indirect tension within it.

The orientation of the fracture surface between B1a and the remnant cliff (Figure 4, acute rather than parallel) is likely to be a result of the eroded morphology of the underlying shale band that had been supporting B1 (Figure 11B). The void under B1 is the result of undercutting erosion into the underlying shale band. This would have occurred preferentially from the outer edges, inwards. This would result in decreased support and stress concentration over time, for the overlying blocks, B1, B2, and B3. The morphology of this under cutting erosion would also have contributed to creep in the overlying rock mass and the outward rotation of B1, away from the cliff face, after the rock mass failed.
