ROCK FALL CASE STUDY: HAWKESBURY SANDSTONE

Daniel Bishop¹, Stephen Fityus², David Piccolo³ and Garry Mostyn³

¹Research Associate, University of Newcastle, ²University of Newcastle, ³Pells Sullivan Meynink.

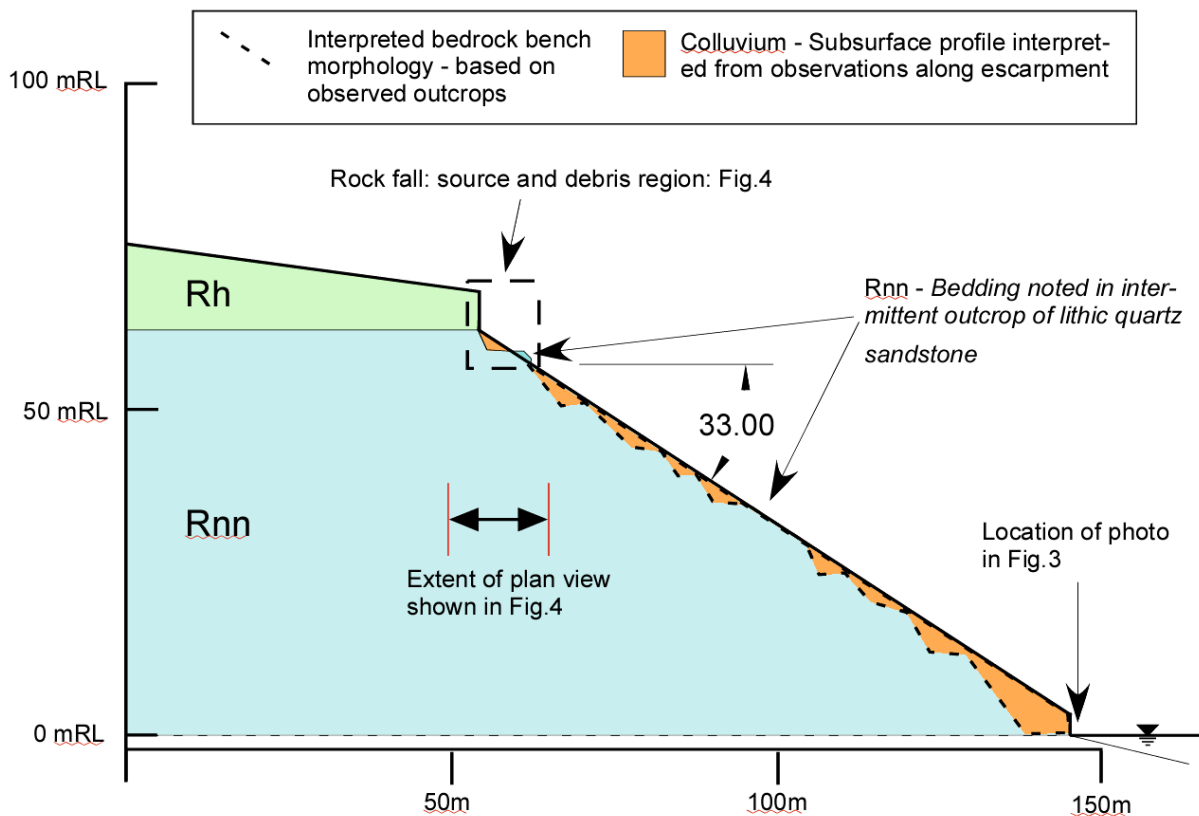
A section through the rock fall site (Figure 2), perpendicular to the valley wall, shows the rock fall source and distribution zone as well as the morphology and interpreted geology of the colluvial slope, below the rock fall down to sea level. The location of the section is shown in Figure 1B. The source of the rock fall is the thick, massive sandstone. The bedrock immediately below the rock fall location consists of inter-bedded shale and thin (1-2 m thick) sandstone units of the Narrabeen Group. The slope below the rock fall source comprises a sequence of preferentially eroded shale units interbedded with protruding sandstone units, forming benches. These benches have been filled to capacity with colluvium comprising sandstone boulders (<1 m) in clayey sand matrix coarsening up to a medium-fine grained sand matrix, resulting in a relatively smooth slope with a maximum steepness of around 34°. There are larger sandstone boulders (1-5 m in maximum dimension) resting on and embedded within the colluvium and these are dispersed across the slope at different elevations. The colluvium on the slopes of the valley is dominated by two soil types. The upper slopes comprise medium grained sand containing boulders and pebbles of sandstone and organic material. The lower slopes (including portions of the Pleistocene terraces) consist of matrix-supported orange/brown gravelly (cobble-sized) clay with some sand (Figure 3).

Figure 2: Cross section through valley slope at rock fall location (A-A in Figure 1).

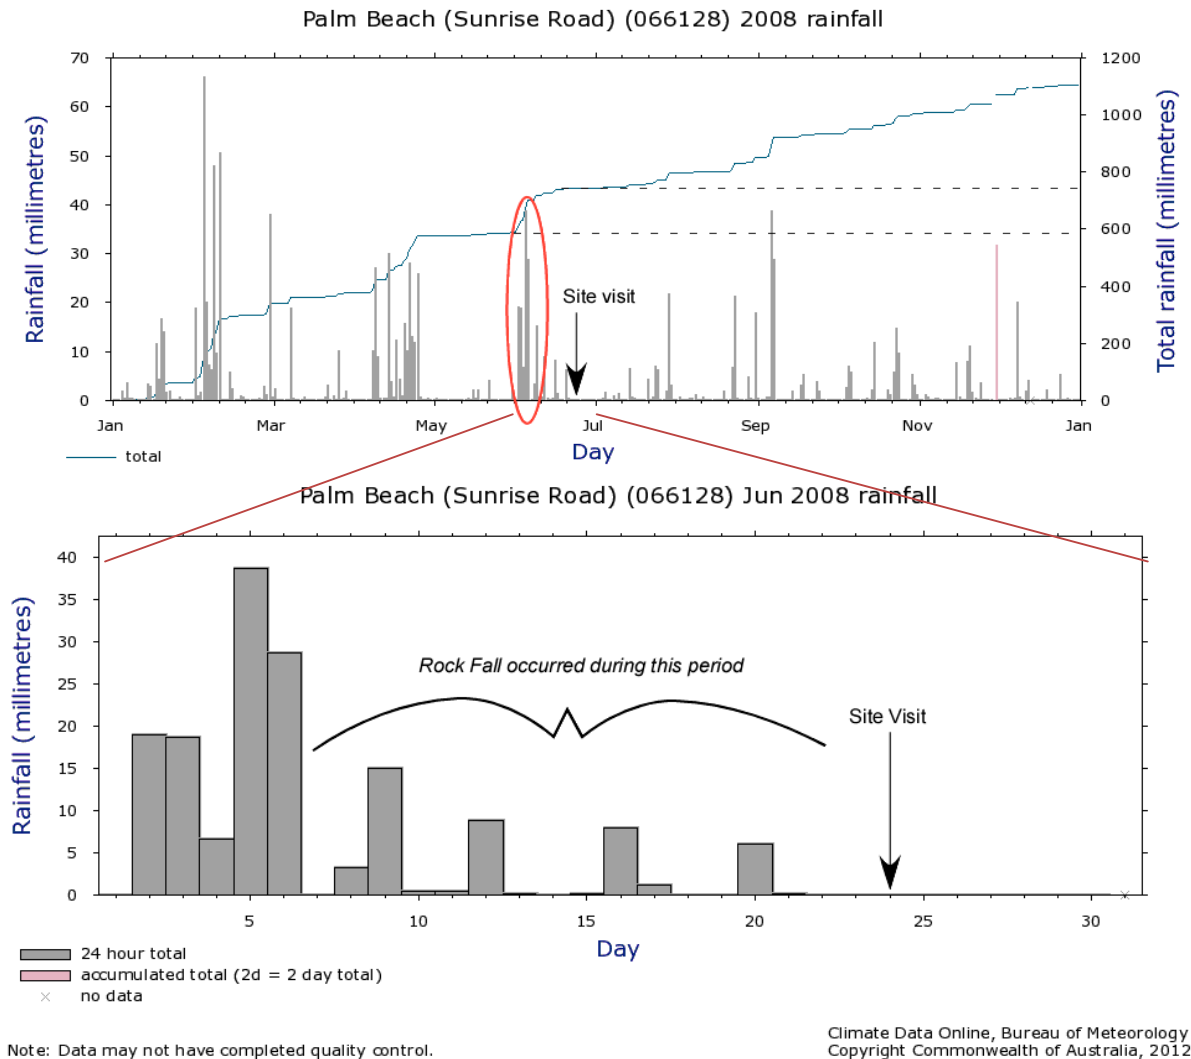
It is certain that the rock fall event occurred sometime between the two site visits on the 9th of January and 24th of June. Measured rainfalls at Palm Beach, on the other side of the Pittwater from Currawong, are shown in Figure 10. A key factor in determining a more precise timing of the event is that although there had been extensive rainfall in the area in the 5 months between the two site visits, none of the impact marks, gouges or fracture surfaces had been washed clean

of the crush debris. Also, soil on the newly exposed surfaces of previously closed joints had not yet been washed off. This indicates that the rock fall occurred sometime after the last significant rainfall event of around 100 mm at the beginning of July. Below are listed the observations that indicate a possible failure mechanism

Figure 10: Rainfall events in early June, 2008, prior to site visit.
