INNOVATIVE SLOPE ENGINEERING – VICTORIA – AUSTRALIA

Tim Holt and Shyamalee Herath
A S James Pty Ltd, Melbourne, Victoria, Australia

This paper demonstrates the approach adopted to provide appropriate solutions with the application of Australian Geomechanics Society (AGS) guide lines [1] for landslide risk management and risk management strategies illustrating five case studies.

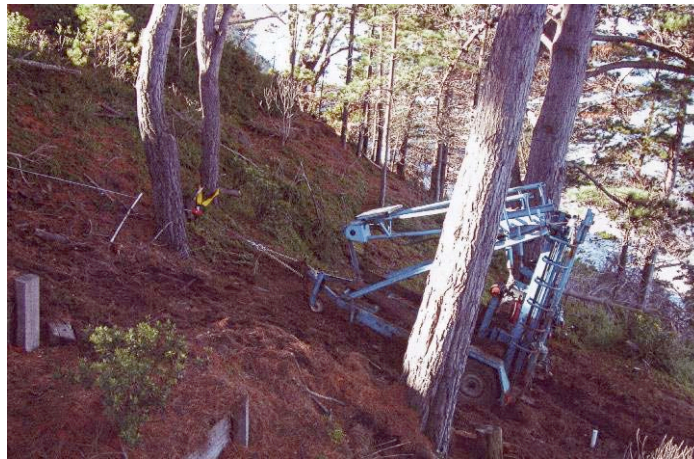
Fig. 4. Spindrift Avenue, Flinders

Vegetation while largely removed was an indicator of the movement (refer Figure 4, taken in 2005) showing in the background pines less susceptible to movement and in the foreground pines clearly moving with the instability.

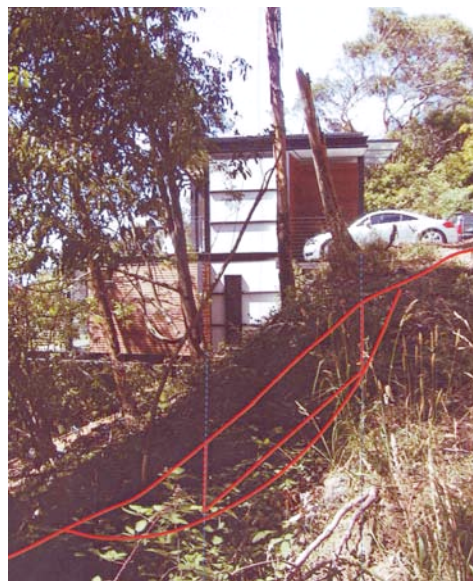
Fig. 5. Solution Concept – Moreley Avenue, Wye River

For this site a block of soil was reinforced by a series of closely spaced piers designed for the lateral at rest pressures that would be mobilized in the longer term against the block. This site had the advantage of a relatively shallow depth to competent rock and the lateral forces could be transferred by frame action and transferred to the rock. Decisions as to soil arching between piers/piles governed the spacing of the piles. The overall site stability was assessed using GEO-SLOPE - SLOPE/W software with the overall site stability increased as consequence of the block of soil to acceptable levels in accordance with the AGS guidelines [1].

The following photographs are indicative of the solutions at this site which is the simplest of the solutions in this paper.

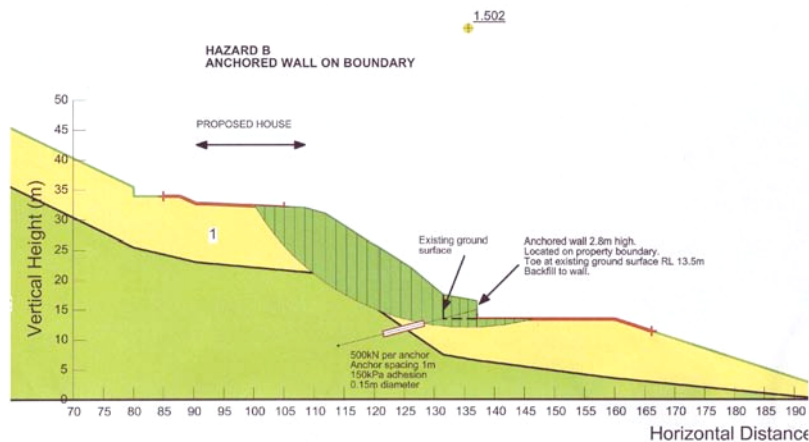
Figure 8: Concept of the Approach Adopted

The following analytical sections are illustrative of the approach adopted with anchors extending beyond the failure plane by a suitable development length. Anchors were spaced at 1.0m of 500kN S. W. L. and some 20-25m long.

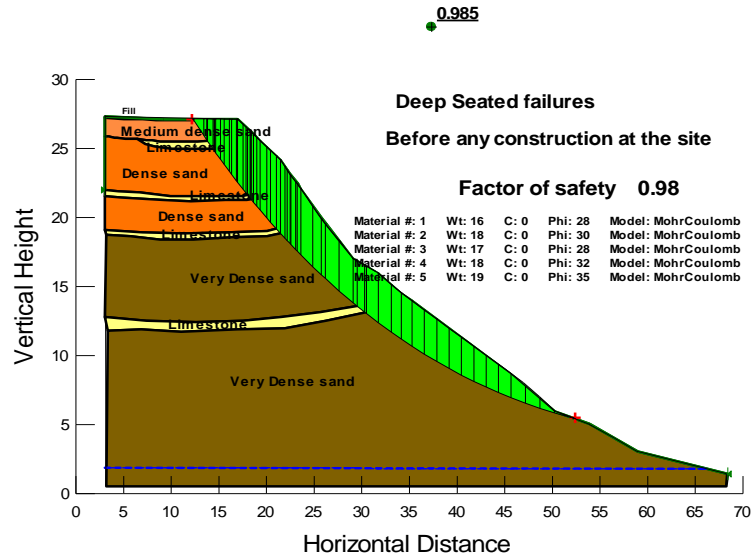
Fig. 10. Slope Stability Analysis

Slope Stability Analysis was carried out for the shallow translational and deep seated failures for the slope before any construction and after the excavation for basement. Subsequent construction of the building indicated unstable to marginally stable conditions (refer Figure 10).

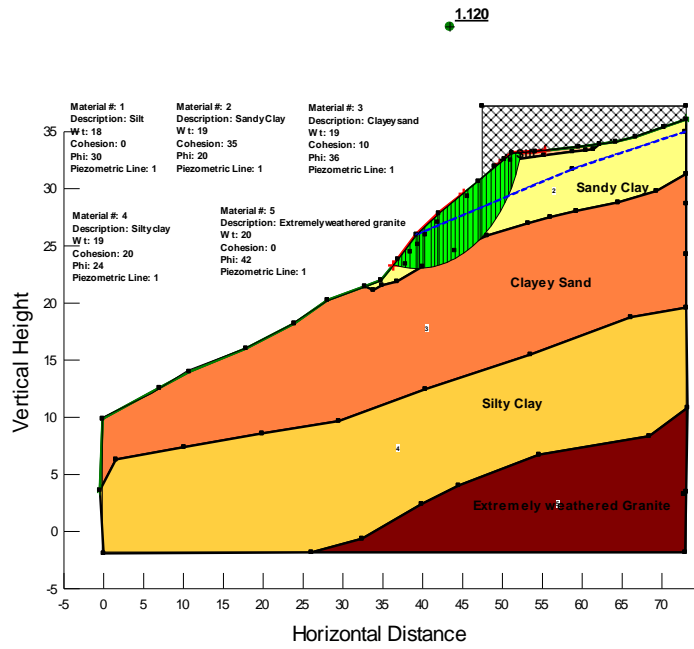
Figure 12: Slope Stability Analysis

Shallow translational and deep seated failures were analyzed and indicated marginal factor of safety of 1.1-1.2 for both shallow translational and deep seated failures (refer Figure 12). It was understood that there is a tendency for deep seated slips due to tertiary clays and anticipated seismic activity, but more risk exists for shallow movements due to moisture build up.

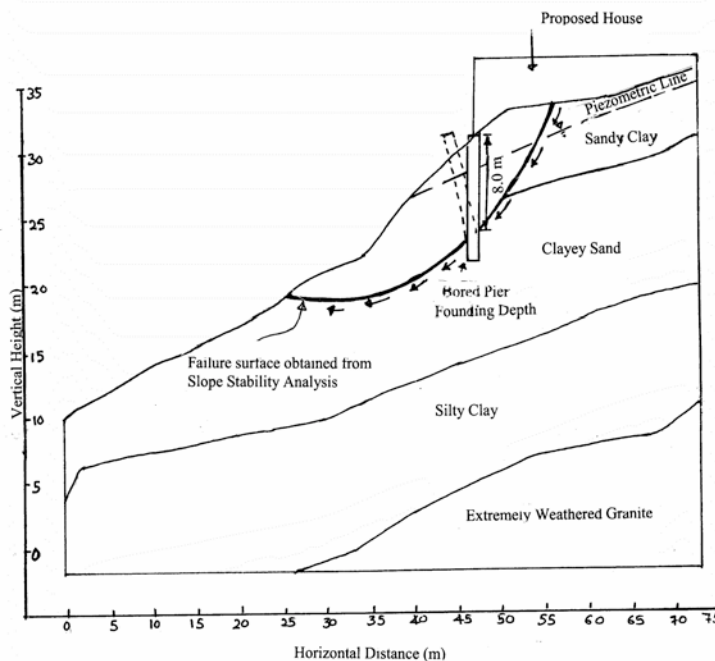
Fig. 13. Bored Pier Founding Depth

Footings were needed to be constructed to a dense sand layer and to a depth obviously below the potential deeper seated failure planes to ensure the soil creep and instability did not influence considerations. Bored pier arrangements with a series of piers were adopted and the design was based on the bored piers being able to withstand a lateral load against the active failure condition. For the proposed house location it was 8 m (refer Figure 13).
