ROPE ACCESS METHODS IN SLOPE RISK ASSESSMENT AND REMEDIATION

Andrew Hunter¹ and Marc Hendrickx²

¹*Coffey Geotechnics Pty Ltd, Lane Cove West, NSW*

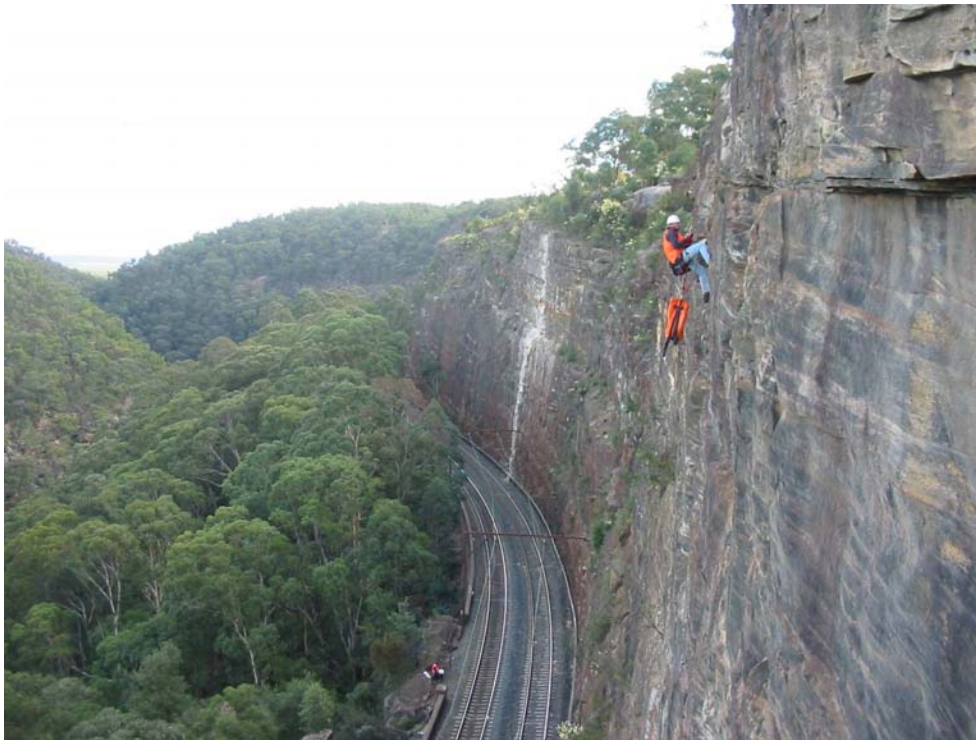
Figure 1: Engineering Geologist assessing slope hazards on the Eastern Cut.

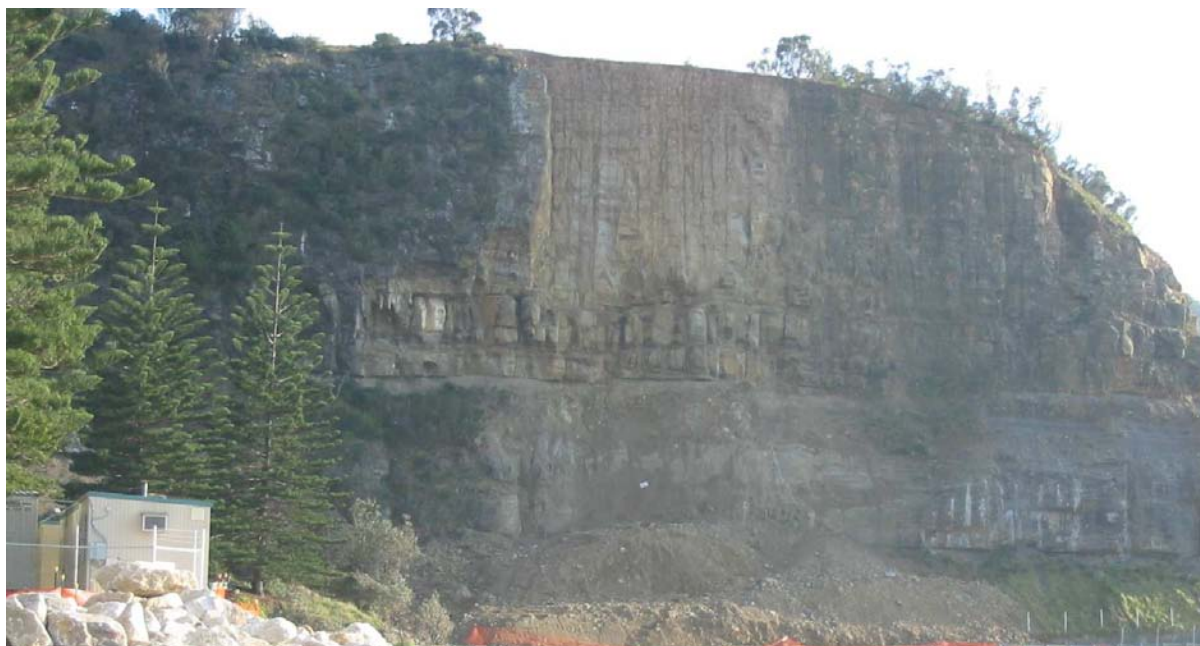
Figure 4: View of GD5 showing cliffs in Scarborough Sandstone following blasting undertaken as part of the geotechnical remediation. The cliffs were subsequently scaled and additional support provided by rock anchors and rock fall mesh. All work, including drilling for rock anchors, was carried out using rope access methods.

GD5 comprises near vertical cliffs up to 30 m high in Scarborough and Otford Sandstone separated by a thin interval of Wombarra Claystone that overlie a headland developed in Coalcliff Sandstone (Figure 4). Both sandstone cliffs are a source of rockfalls to LHD below. The slope above the cliffs is relatively flat with good 4WD vehicle access via the adjoining coke works in Coalcliff.

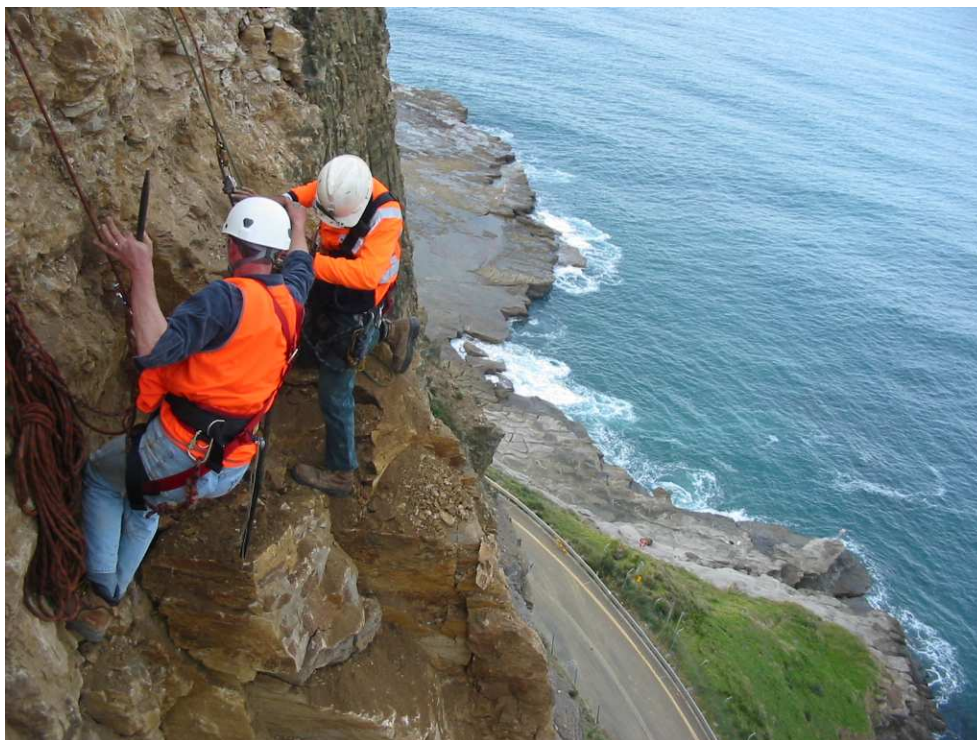
Figure 5: Engineering Geologists supervising scaling works in GD5. Note rope and equipment set up and Lawrence Hargrave Drive about 40 m below.

Work by rope access trained engineering geologists involved inspection of hazards, mark-up of rock anchor locations, supervision and planning of PCF® low energy explosive works, and general oversight of slope stabilisation works (Figure 5). The area above the cliffs was cordoned off with barrier fencing to restrict access to the cliff edge. Set up of ropes utilised large trees set back about 10 m from the cliff edge as anchor points. These were later supplemented with steel rock anchors that were to be used to hang steel rock fall mesh. Scaling and rock removal work was initially carried out from the top down to remove fractured rock masses resulting from blasting. Radio contact was maintained between team members and a lookout on the road below, who would halt rope access work to allow for the safe passage of construction vehicles. Rope protectors were used to prevent damage to ropes at the sharp cliff edge and locally on the cliff face where sharp sandstone protrusions outcropped. Bags and lanyards were used to secure equipment such as crow bars, cameras, range finders, paint and writing material to prevent them falling below. As there was no quick access to the crest of the cliffs from below, all down traverses required a climb back up the cliffs.
